# Adirondack Watershed Institute Stewardship Program Summary of Programs and Research 2015

Adirondack Watershed Institute  
Report # AWI 2016-05

# Adirondack Watershed Institute Stewardship Program

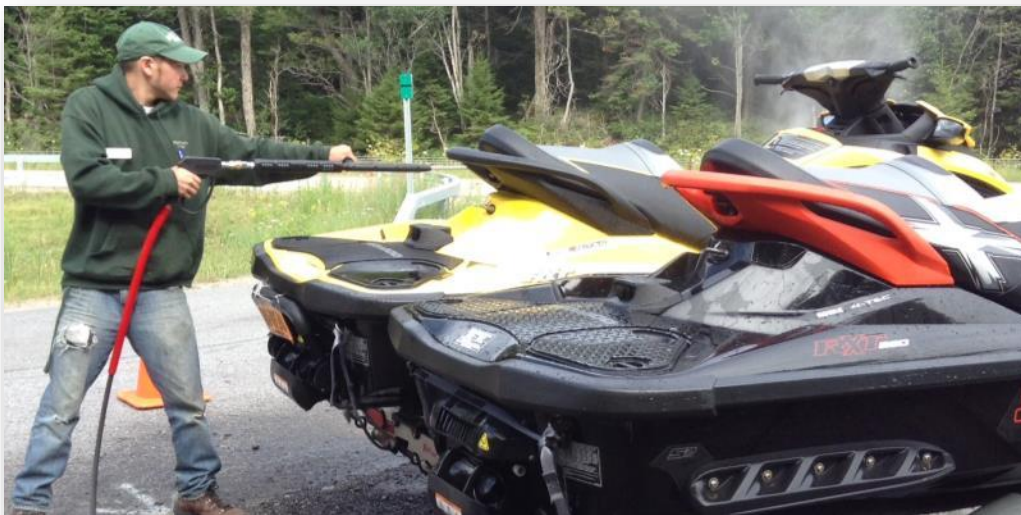
**Steward decontaminating two personal watercraft.**

Stewards conducted decontaminations by moving from the inside to the outside of each vessel. Internal compartments found with standing water were flushed with low-pressure hot water (140 degrees F). This includes bilges, ballasts, and live-wells as well as any other area where standing water may have accumulated. If rigging, fishing lines or other gear was found to need decontamination, the items were removed from the vessel if possible, and placed on the ground for high-pressure hot water decontamination. If equipment was considered too delicate for high pressure, then low-pressure hot water was used.

Outboards and lower units found with standing water in them underwent a flushing process, which consisted of low pressure hot water being supplied to the lower unit with flushing muffs, the boater starting the motor, and running the motor until the cooling water discharge was 140 degrees F. Temperature could be adjusted on the LANDA units and was measured with a laser thermometer or by observation of sufficient steam water vapor. Lastly, hulls that required decontamination were carefully washed with high pressure hot water. Technicians directed wash water to remove surface organisms by holding the wash wand at a 45-degree angle to the hull of the boat and slowly sweeping in one direction. Technicians used various decontamination methods to most effectively clean various features on watercraft, such as pontoons, outdrives, and other equipment.

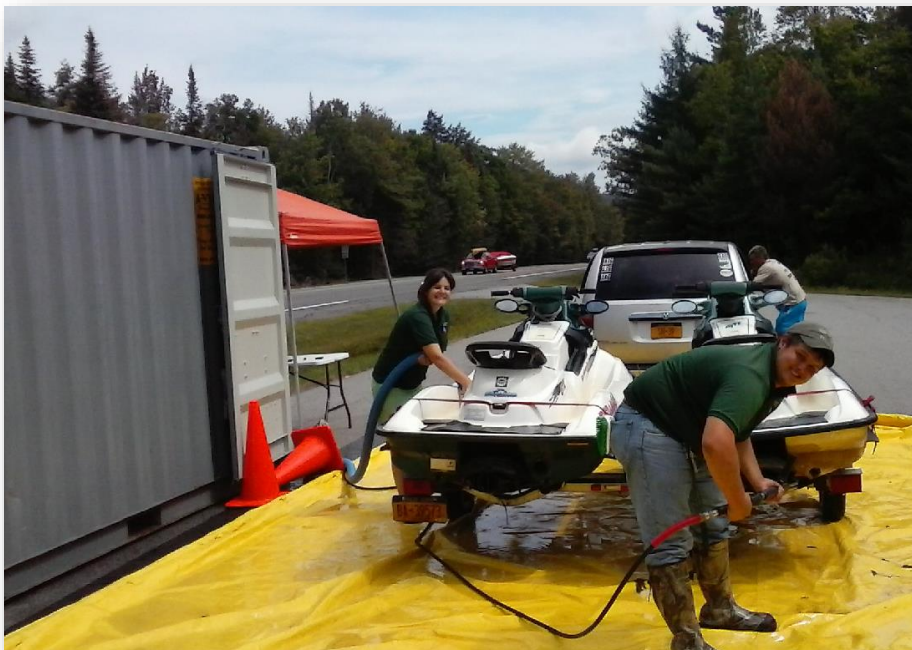
**ECOS unit in operation with storage container and wash water mat.**

Pressure washing units were stored and locked in appropriate sized portable storage containers, (MHC units required a 10 foot long container, ECOS units required 20 foot containers) which also housed signs, personal protective equipment, cones and other gear such as lower unit flushers, buckets, and tarps. Personal protective equipment provided to the stewards included, tinted safety glasses, face shields, gloves, ear protection, high visibility orange vests, and hard hats. ABC type fire extinguishers were provided at all decontamination sites. Signs and cones were set up and taken down each day at the beginning and end of shifts. NYS Department of Transportation (NYSDOT) signs could also be opened and closed in many locations to avoid confusion when stations were not in operation. Technicians would set up the pressure washing units at the beginning of their shift and run the unit to ensure that it was ready for use. Units were allowed time to cool before being placed into the storage containers and locked for the night. Cones and signs were set up in a way that allowed for inspections and decontaminations to take place at the same time if needed. Oil absorbent socks were placed along infiltration basins to wick up any oil that might be washed off during decontamination. An effort was made at all times to not obstruct the flow of traffic and to keep all involved at safe distance from moving vehicles.

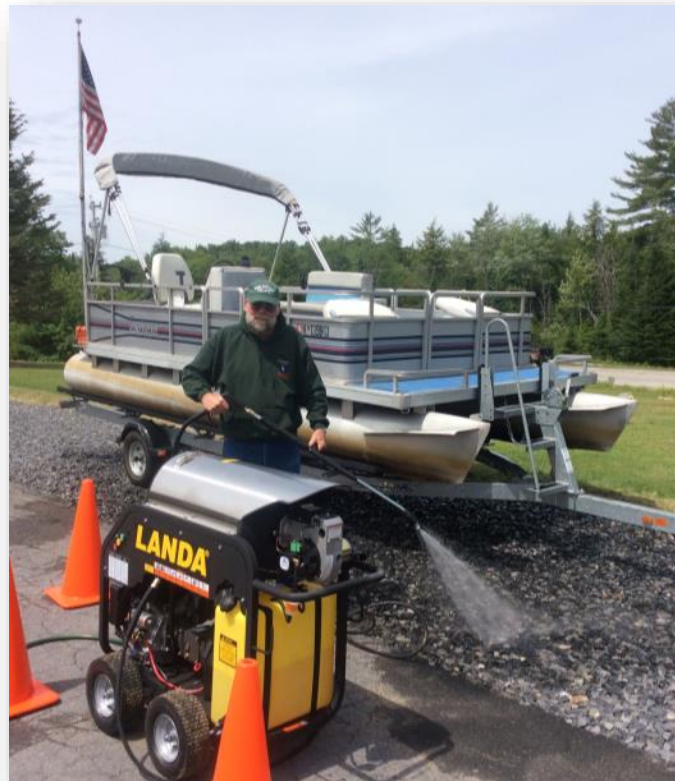
Figure 6. Decontamination station with high pressure, hot water unit and run-off percolation pad.

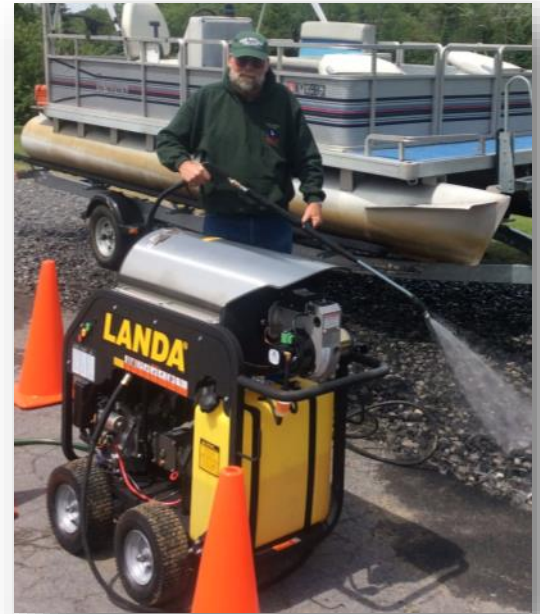
Landa MHC high pressure hot water unit in action.

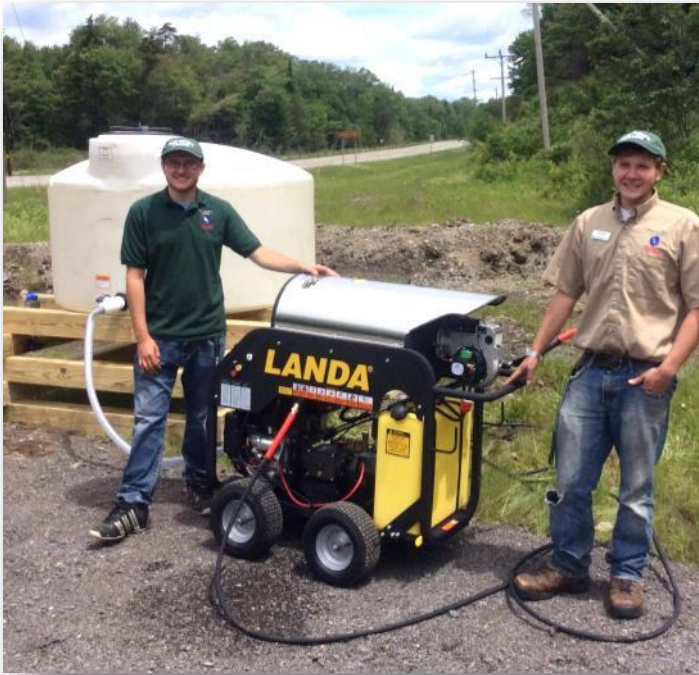
Elevated water supply tank and cribbing- Okara Decontamination Station.

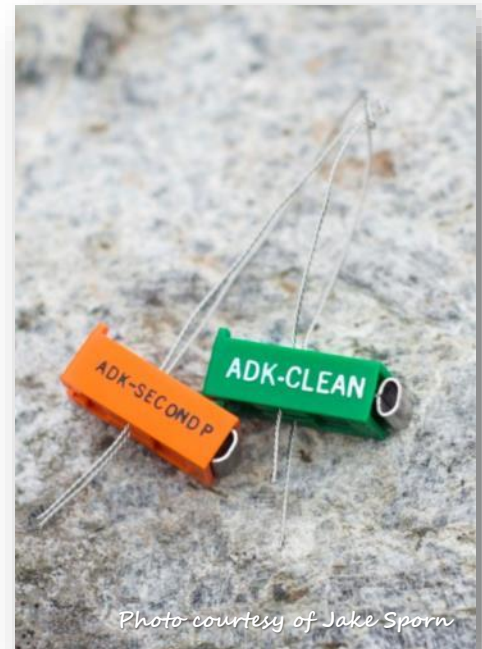
**Boat decontamination tags furnished by the S.A.V.E. Lake George Partnership.**

Because this system was adopted from the Lake George program, which has a mandatory inspection policy and different coverage and staffing practices, there were limitations on how fully it could be implemented in the AWISP, with its voluntary compliance protocol. An advantage of the tag system is that it helped stewards at the launch identify vessels that presented substantially reduced risk of transporting new AIS either because the previously visited water body was that very lake or because they had been inspected at another inspection site and either passed or were decontaminated. The AWISP will continue the tag program in the 2016 season. We are optimistic that with repetition, users will come to expect and appreciate the tag system.

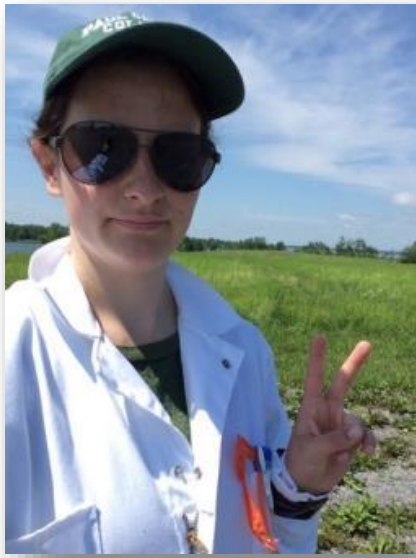
**Steward Jennifer Ryan sporting tick-sampling attire.**

In order to collect the ticks, a one square meter strip of corduroy was tied to a wooden pole by a piece of rope and dragged through knee high grass. The strip was dragged for 1000 meters at a time, inspecting the strip for ticks every twenty steps. There were anywhere from 4-8 tick drags completed at each location. The

required attire for gathering this research was long pants, a long sleeved shirt, thick socks and closed toed shoes, with a white body suit to top it all off. The clothing is mandatory in order to protect stewards from getting bit by ticks, as they were not allowed to wear any bug repellent while collecting this data. Other types of equipment used during this study were: tweezers (to collect the ticks off of the corduroy) and vials filled with ethanol (to preserve the ticks).
