# Final Project Report 2010

## Eastern Lake Ontario Upper Watershed AIS Response Team

Daniel L. Kelting  
Executive Director  
Paul Smith's College  
Adirondack Watershed Institute  
GLRI/USFS Grant # 52270-B-G010

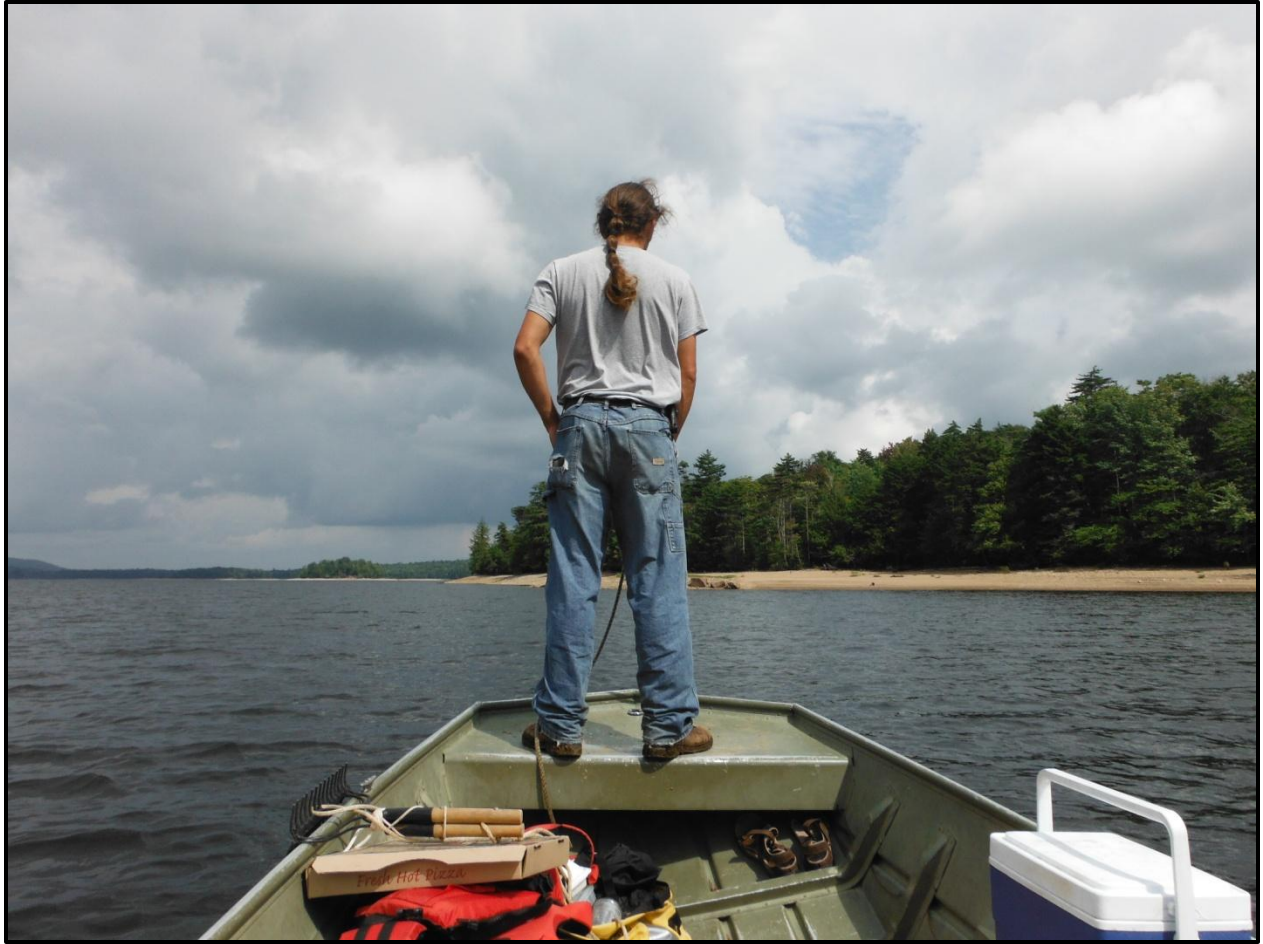
**Photo 3.** Josh Fitzgerald conducts a surface survey of Stillwater Reservoir. When possible large lakes are surveyed using a combination of canoes and motorboats.

The ED team performed whole lake aquatic plant surveys using a combination of visual surveys and rake tossing. The team surveyed the entire littoral zone of each lake in a serpentine search pattern and mapped the location, species composition, and species abundance of all aquatic plant beds. Bed perimeters were mapped with a handheld GPS unit and field data were recorded on a datasheet (Appendix 1). Visual surveys were supplemented by periodic rake tossing using a consistent protocol (Appendix 2). All field data were entered into ArcGIS to create aquatic plant maps for each lake. When AIS were encountered, separate maps that showed the locations and abundance of the AIS were created. The ED team received two weeks of intensive training on native aquatic species and AIS identification, as well as field survey techniques, prior to performing any lake surveys. When deployed, the ED team worked in two person crews under the supervision of a crew chief (Photo 1). The surveys were generally done by canoe (Photos 1, 2, and 4), but a motor boat was used when possible in larger water bodies (Photo 3). Each crew was equipped with a bathymetric map of the lake, portable depth sounder, handheld GPS unit, two-sided rake, and a digital camera. Depths were checked periodically while surveying to ensure that the far shore edge of the littoral zone was covered. Photos were taken of new species and any AIS encountered.

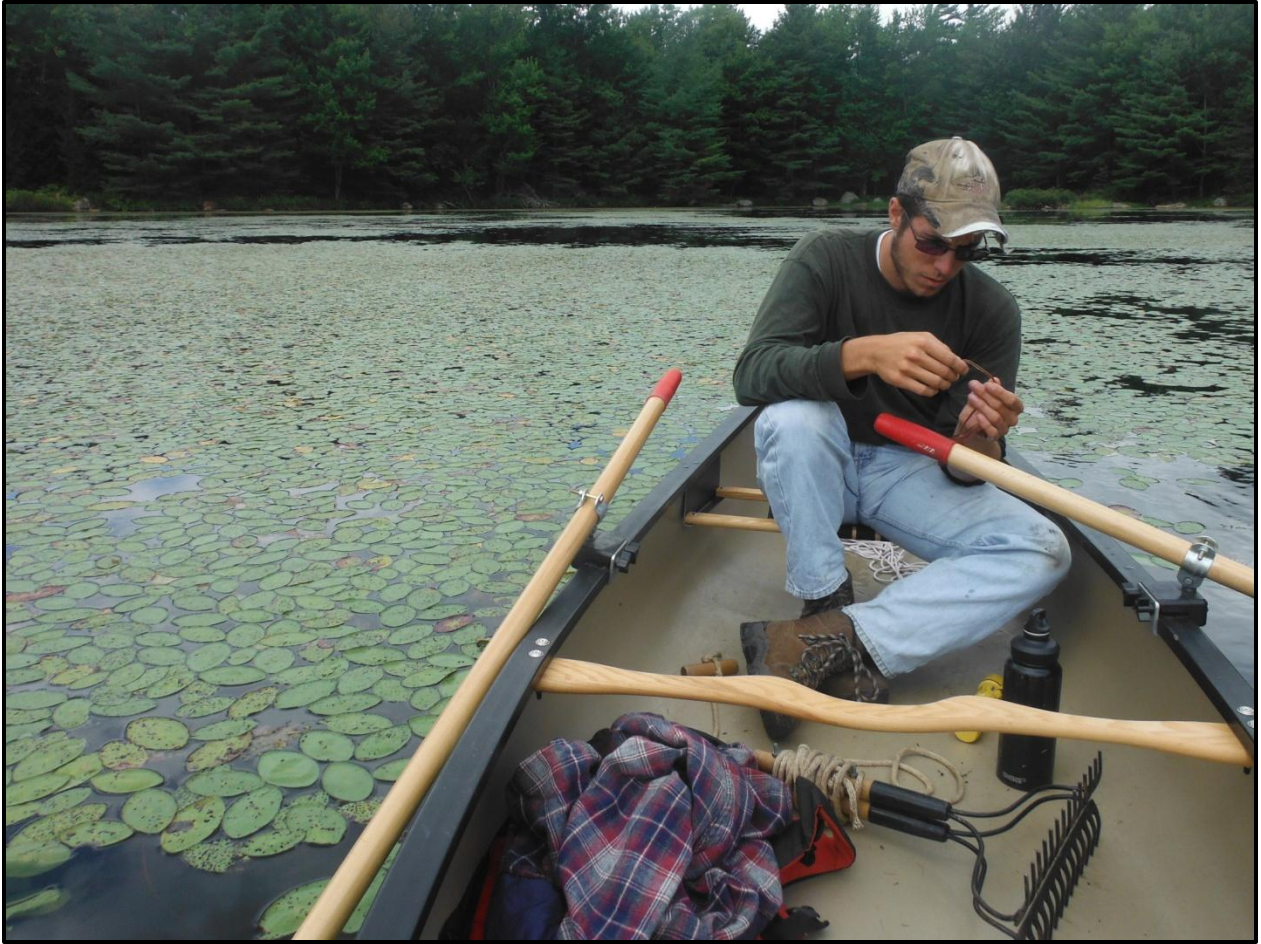
**Photo 4.** Josh Pierce identifies a species of aquatic plant after performing a rake toss in Lake Meacham.

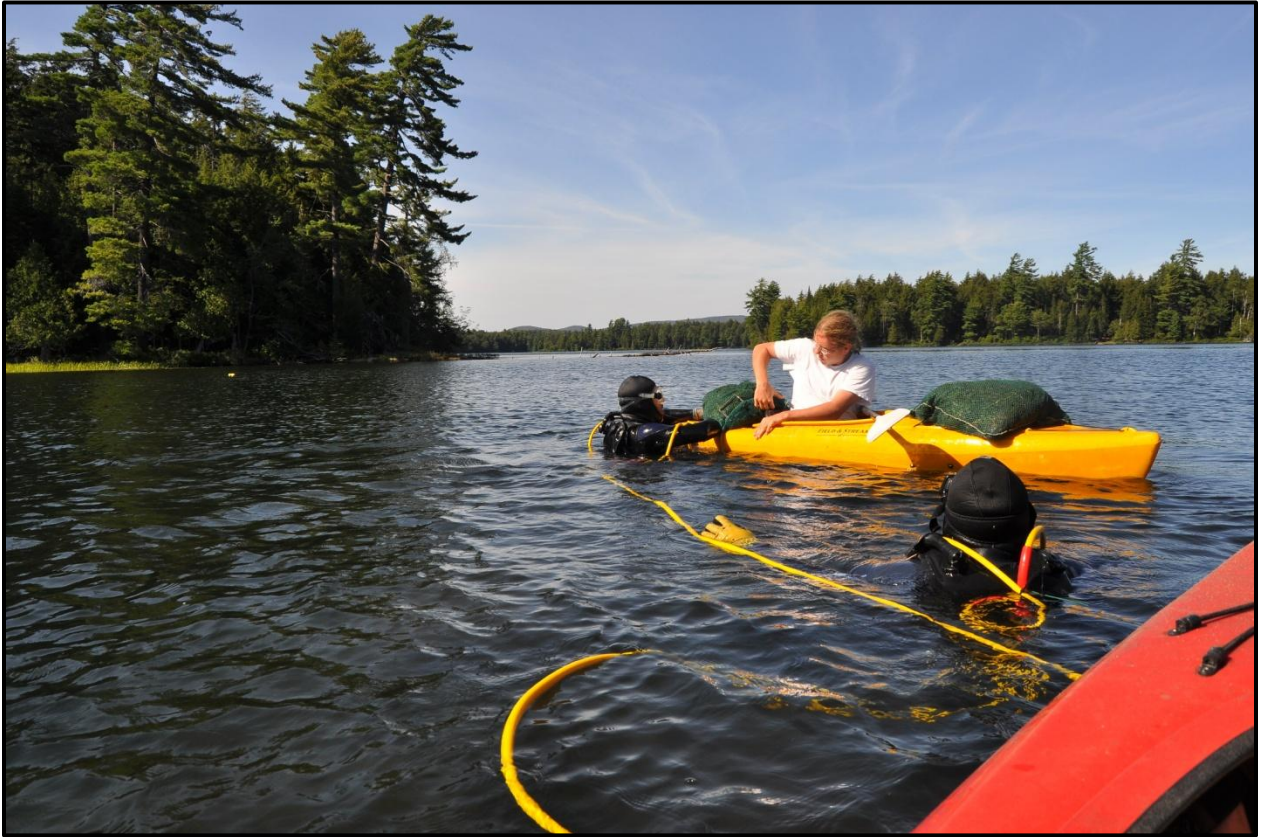
**Photo 6.** Rapid response management team hand harvesting Eurasian watermilfoil in the Fulton Chain. Note yellow hoses supplying air to the divers from the hookah rig and the green bags filled with milfoil on the deck of the kayak.

The RR team followed best management practices for hand-harvesting aquatic plants. Invasive plants were hand-harvested using three divers (1 lead and 2 support divers) with breathing air supplied by a floating hookah rig. The divers carefully removed the entire aboveground portion of the plant and as much root material as possible. The plants were placed in mesh bags that weighed approximately 50 pounds when full. Full bags were brought to the surface and handed off to a top water support person in a kayak. The top water support person handed the diver an empty bag and dumped the full bag in a disposal boat. The top water support person also collected plant fragments floating on the surface and warned other boats away from the dive area. Before entering the water, the lead diver marked the work area with buoys and decided on the approach for harvesting the area; either quadrant harvesting in dense areas or line harvesting in more sparse areas. In quadrant diving each diver worked their own area, while in line harvesting the divers swam a straight line in sight of each other to harvest scattered plants. The team maintained a daily log of activities. The team was provided with a map of the lake, a GPS unit (Garmin ETrex Vista), and data sheets. The team filled out a new data sheet for each work area each day. This data was then transferred into ArcGIS to produce an operational survey and accounting of removals for tracking and reporting progress. Harvested material was disposed of at designated sites approved by local and state authorities. The RR team also took precautions to sanitize their gear and watercraft before traveling between waterways.

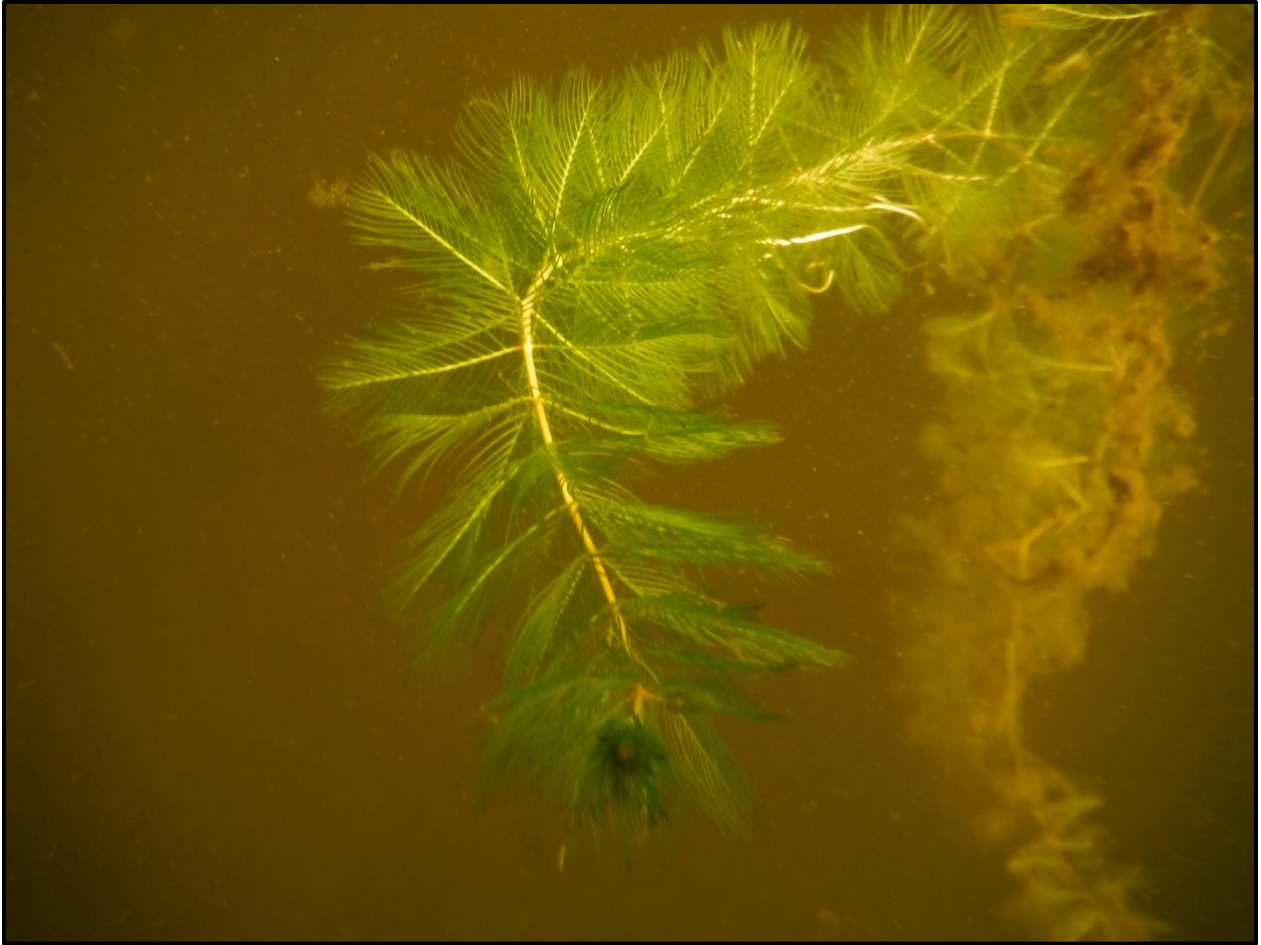
**Photo 7.** Underwater photograph of Eurasian watermilfoil taken in Lake Colby on July 13, 2012.  
Note white rootlets midway down stem.

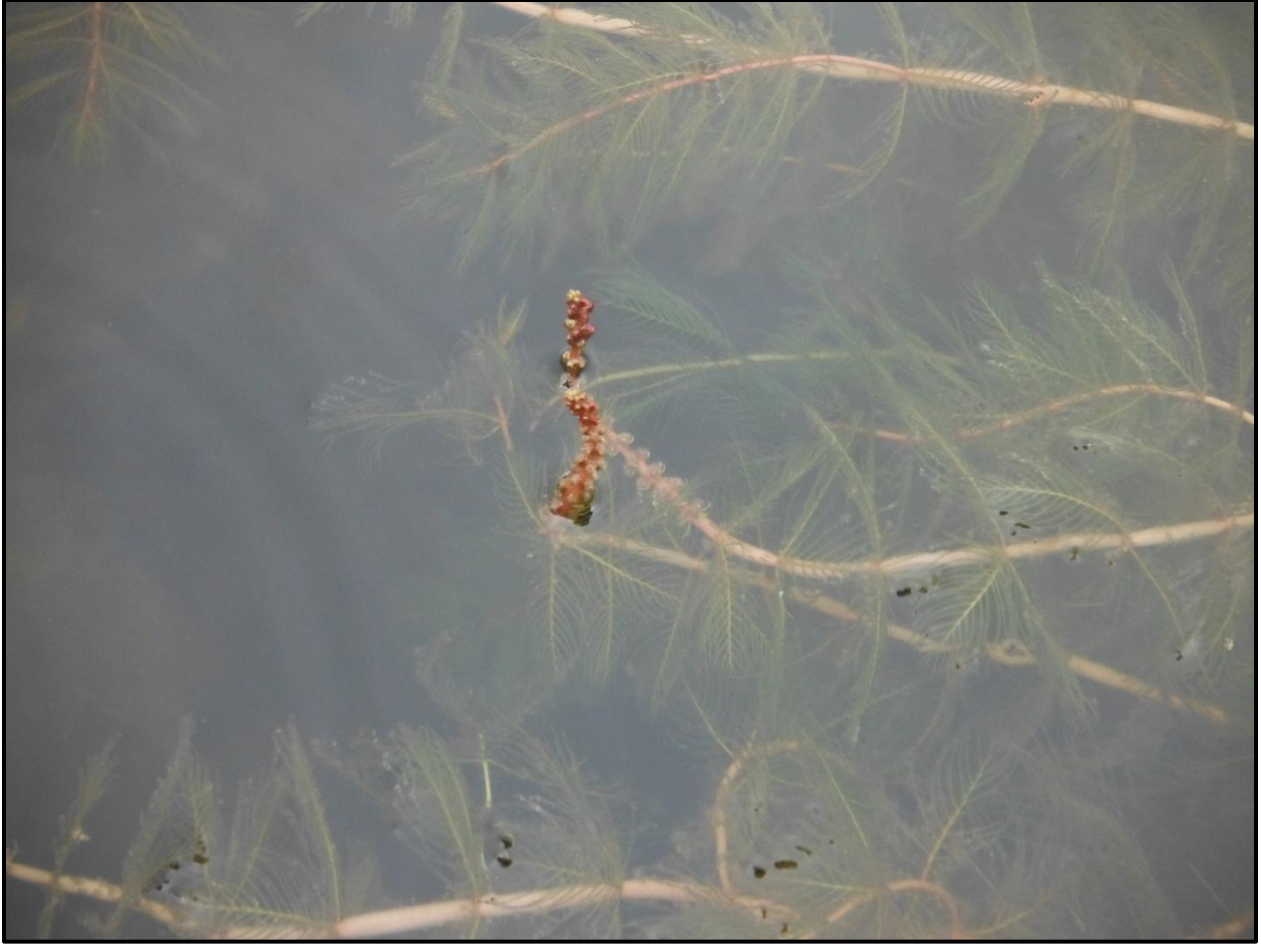
**Photo 8.** Surface water photograph of Eurasian watermilfoil taken in Lake Colby on July 13, 2012.  
Note spikes emerging from the water at the end of the stem that give this species its name.

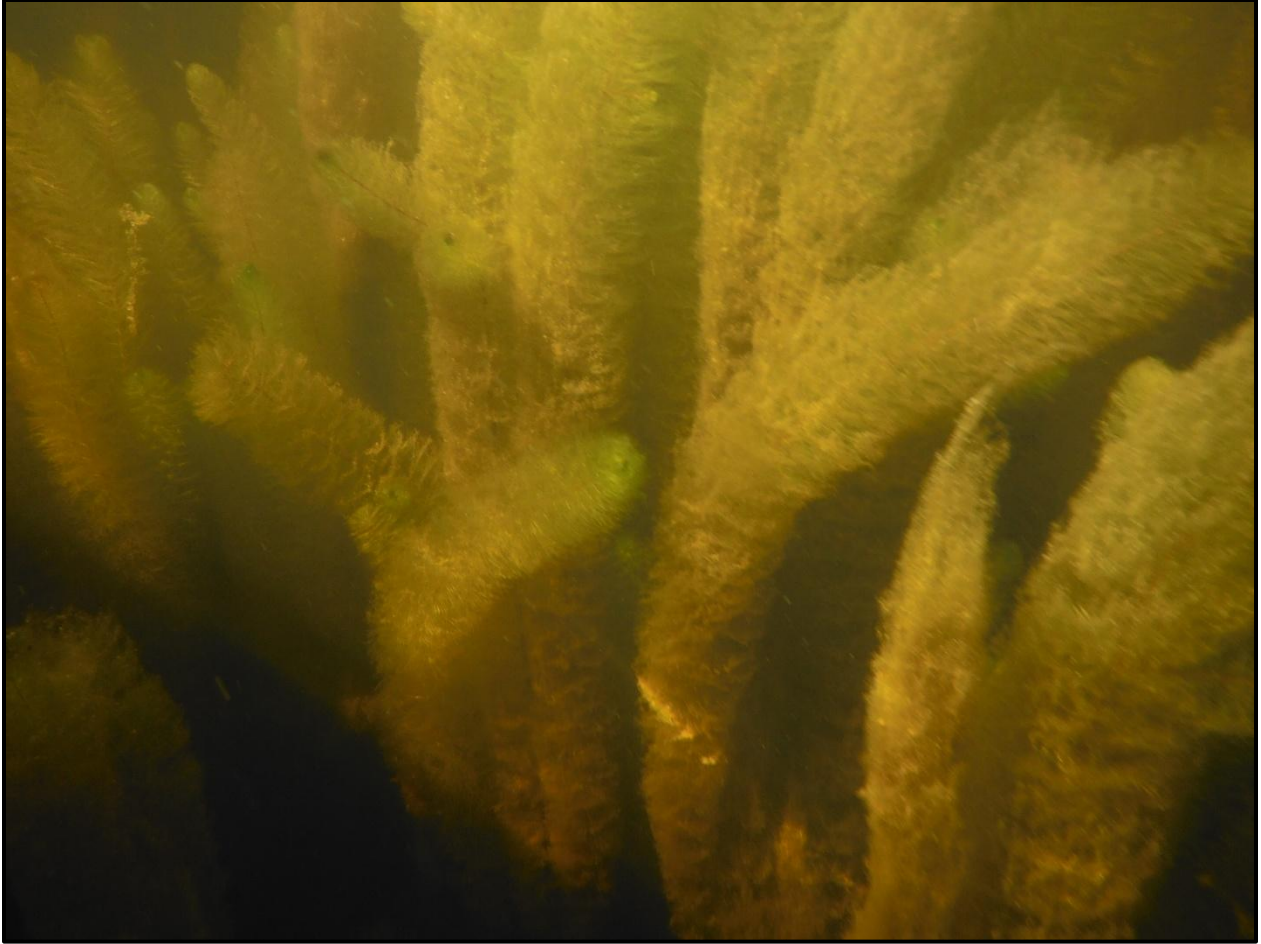
**Photo 9.** Underwater photograph of Variable-leaf milfoil taken in Stark Falls Reservoir on June 19, 2012.  
Note the “foxtail” like growth form and algae on leaves.

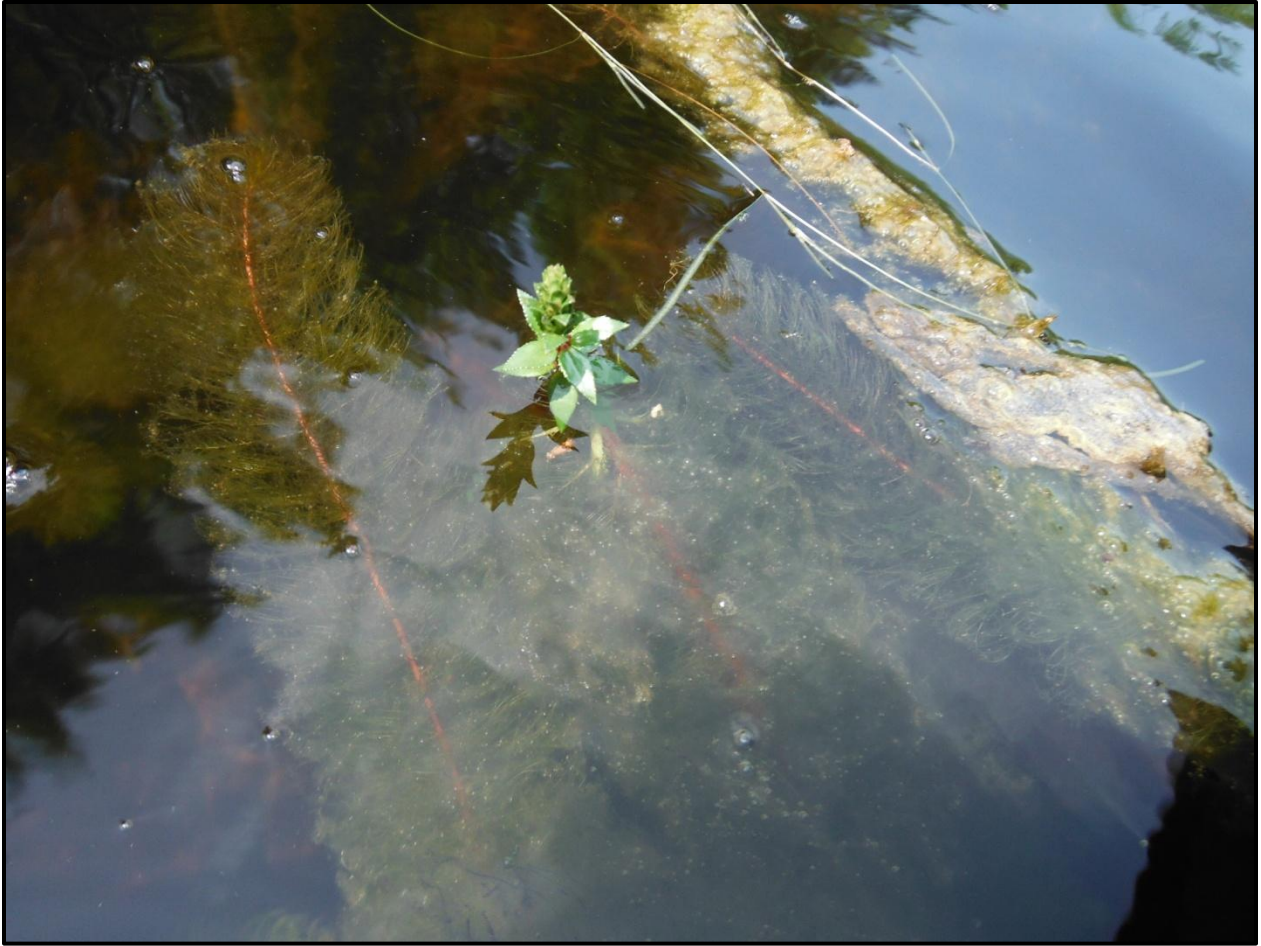
**Photo 10.** Surface water photograph of Variable-leaf milfoil taken in Stark Falls Reservoir on June 19, 2012.  
Note the flowering structure emerging from the water at the end of the stem.

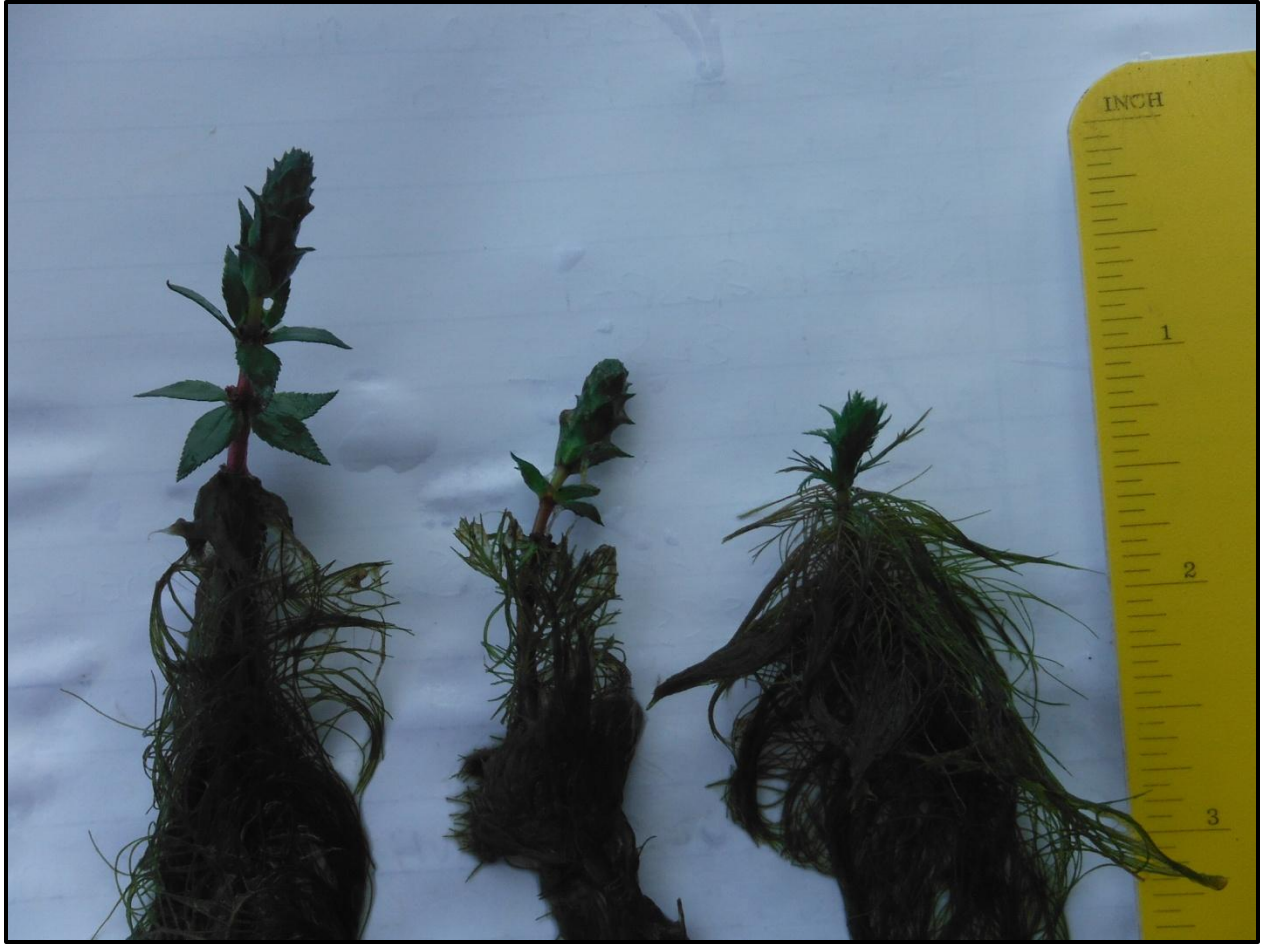
**Photo 11.** Photograph of flowering structures of Variable-leaf milfoil taken from Stark Falls Reservoir on June 19, 2012. Note the entire and finely-divided leaves that give this species its name are easily seen.

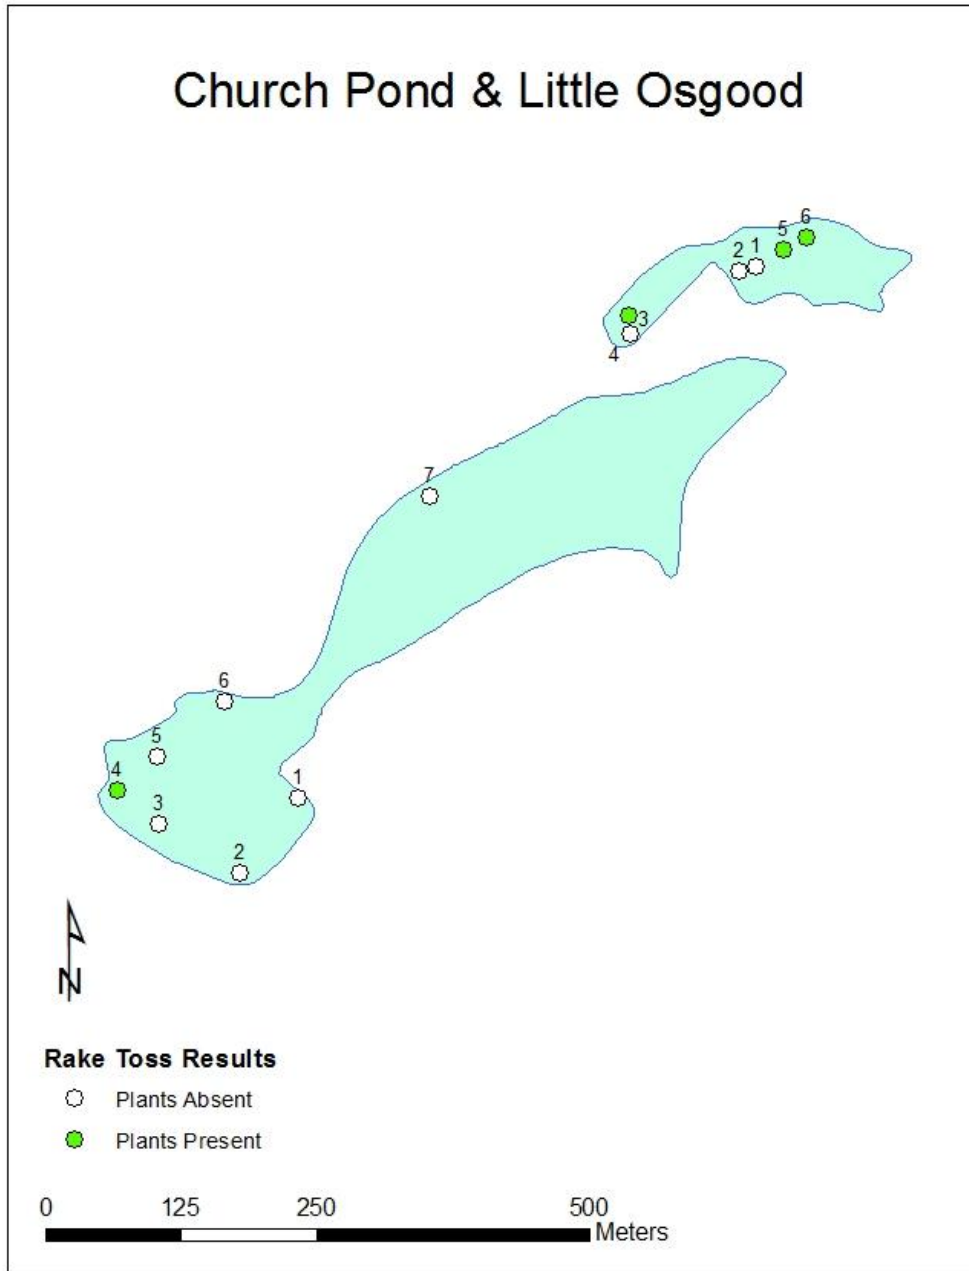
Map 17: Rake toss locations on Church Pond & Little Osgood, 12 June, 2012. Open circles represent locations where no plants were detected, closed circles represent locations where plants were encountered on the rake.

Data for Rake Tosses can be found on Table 12.
